Evaluation of Irrigation Network Performance in Irrigation Areas Jegong Suren Village, Ledokombo District Jember Regency with E-PAKSI

Nanang Saiful Rizal^{1*}, Amri Gunasti² and LukmanEko Prasetyo³

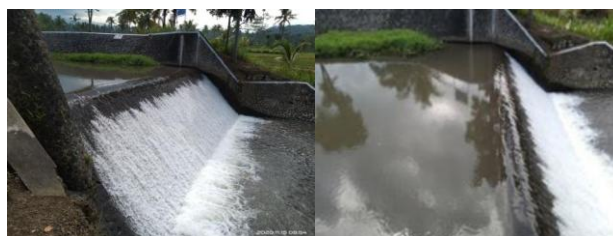
- a. **Weir Crest** :The construction of civil buildings on the Jegong Dam lighthouse is still intact and in good condition. As for the existing condition, no significant damage was found to the civil building of the crest, only less than 20% of the surface of the dam crest was peeling off. The pillar on the drain door has a crack of less than 20%.

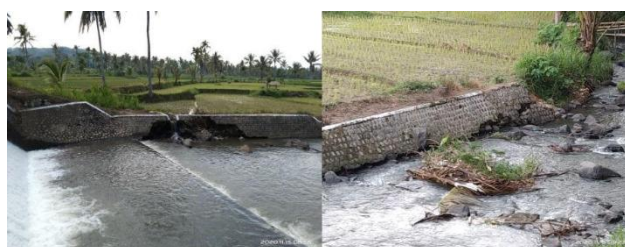
- b. **Weir Wings** : The construction of civil buildings on the wing of the Jegong Dam on the right side at the time of the assessment looked good and in good condition. It is only necessary to clean the rising sedimentation so as to reduce the wet cross-sectional dimensions of the Dampar River. Meanwhile, the construction of the wing of the Jegong Dam on the left side at the time of the assessment appeared to be badly damaged. The damage began to be discovered in the performance assessment in 2019 which began to erode the lower part of the Jegong Dam wing construction building.

And in the 2020 performance assessment, the damage to the construction of the Jegong Dam wing is getting worse due to flooding during the rainy season. So the overall performance assessment for building construction on the wing of the Jegong Dam is in the medium criteria. At the Jegongweir there is no bridge over the lighthouse, operation board, and weir safety fence.

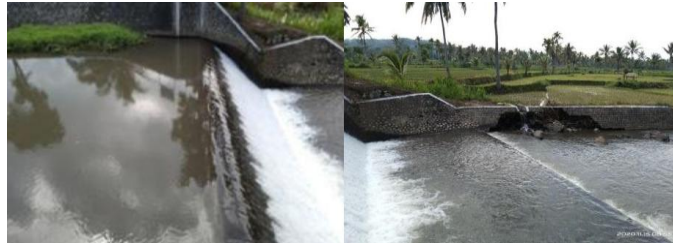
- c. **Weir Floor Upstream** :The condition of the upstream dam floor is not visible because it is covered with water and sediment. The swimming pool is in good condition and the building damage is less than

20%. The condition of the leak on the dam floor is good. The condition of the riverbed at the upstream of the weir there is quite a lot of sedimentation. While in the downstream there is no change in the riverbed. The surface layer of the upper weir floor is not visible due to sedimentation, and the downstream part is also in good condition.

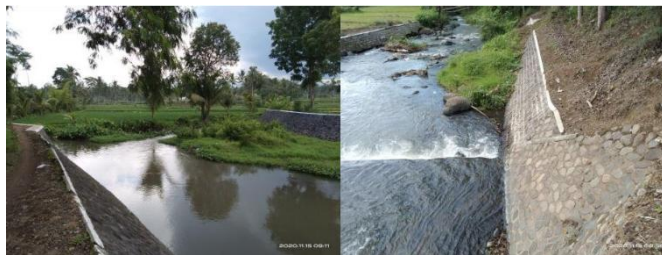
- d. **Weir Embankment** :Overall the condition of the upstream and downstream dam capping embankments is good. It is only necessary to repair the left flank of the downstream side of the weir so that it does not affect the collapse of the left embankment and flood the agricultural area.

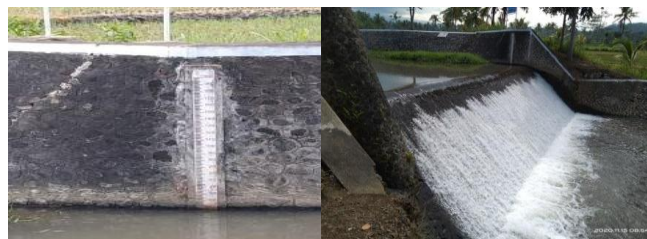
- e. **Weir Bridge** :At Jegong Weir there is no bridge over the weir lighthouse, so the weir operational officers find it difficult to carry out maintenance activities on the part of the weir on the opposite side.
- f. **Operation Board and Weir Ruler** :The Jegong Dam is not attached to an operation board. The operation board needs to be installed to make it easier to record the water debit both at the intake and at the drain door. In general the condition of the ruler is still in good condition and the numbers can be read quite clearly. The position of the ruler installation is also appropriate.

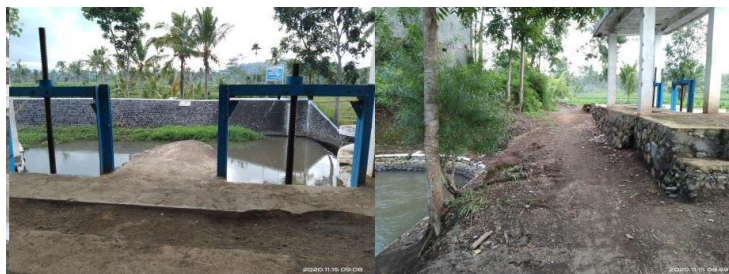
- g. **Safety Fences on Weirs and Weir Doors** :At the Jegong weir there is no safety fence, in the future it will need to be installed as a security sign for state land boundaries. All doors can operate properly and smoothly. The condition of the door leaf, the door handlebar is installed in good condition, no damage or leakage was found. Lifting equipment (morheis) sill, steel sporing is in good condition and can be operated. The door guard house is in moderate condition, and needs to be treated so that it doesn't get damaged

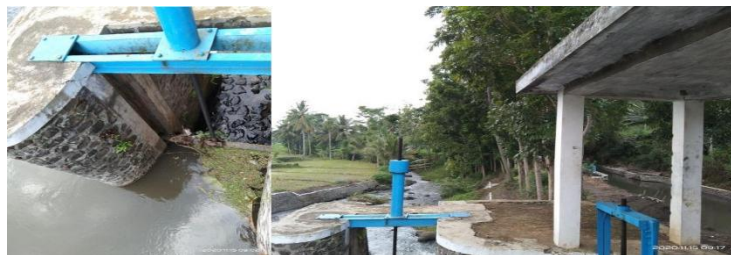
- a. **Weir Drain Door :** The drain door can operate properly and smoothly. The condition of the door leaf has a slight leak from the wooden beam, the door handlebar is installed in good condition, no damage was found. Lifting equipment (morheis) sill, steel spooring is in good condition and can be operated.
