Lampiran 1

NO River Sta	OUTPUT HEC-RAS (Eksiting)
80	<p>Analisa penampang Plan: analisa penampang simpangan hlr Sta 80 26/09/2017</p> <p>Legend: EG Max V/S VS Max V/S Ground Bank Sh</p>
70	<p>Analisa penampang Plan: analisa penampang simpangan Sta 70 26/09/2017</p> <p>Legend: EG Max V/S VS Max V/S Ground Bank Sh</p>
60	<p>Analisa penampang Plan: analisa penampang simpangan Sta 60 26/09/2017</p> <p>Legend: EG Max V/S VS Max V/S Ground Bank Sh</p>

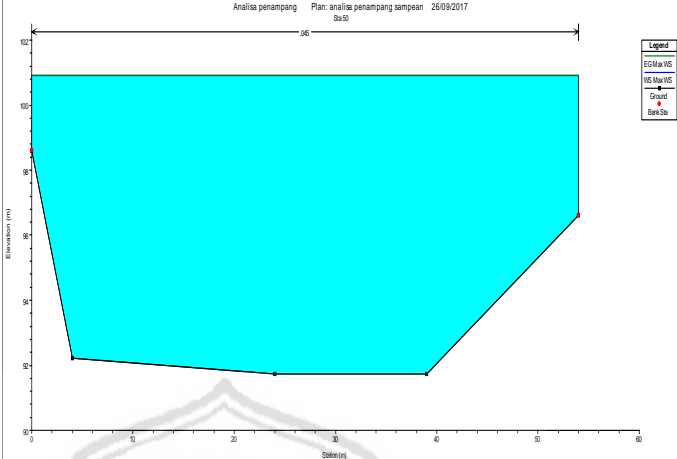
NO River Sta	OUTPUT HEC-RAS (Eksiting)
50	<p>Analisa penampang Plan: analisa penampang sampian 26/09/2017 Sta:50</p>

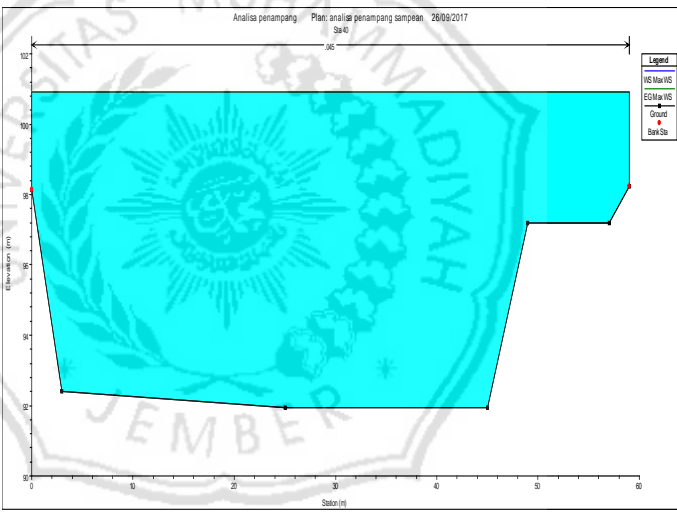
<p>Legend</p> <ul style="list-style-type: none">EGM/HSHS Max/HSGroundBank/Sta
40	<p>Analisa penampang Plan: analisa penampang sampian 26/09/2017 Sta:40</p>

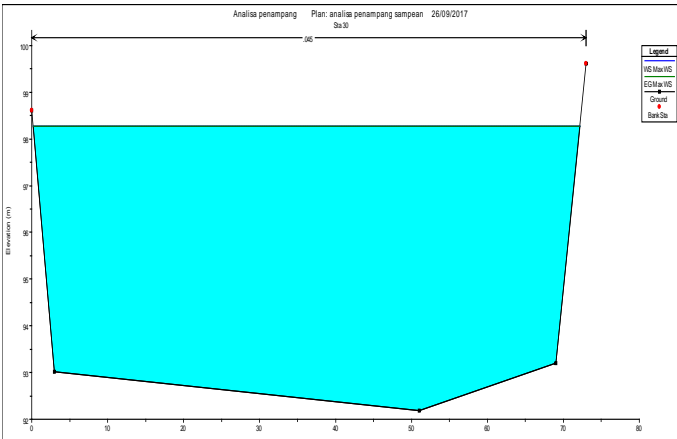
<p>Legend</p> <ul style="list-style-type: none">EGM/HSHS Max/HSGroundBank/Sta
30	<p>Analisa penampang Plan: analisa penampang sampian 26/09/2017 Sta:30</p>

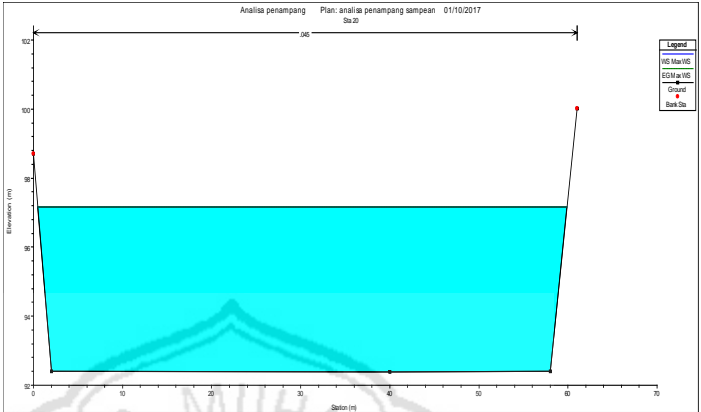
<p>Analisa penampang Plan: analisa penampang sampelan 01/10/2017 Sta:20</p>
10

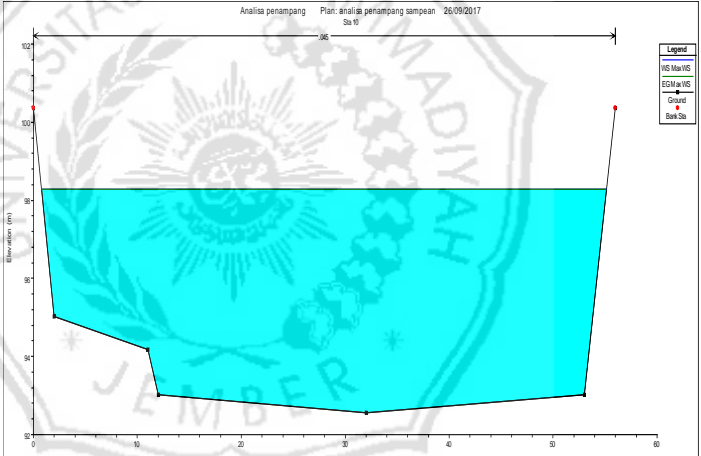
<p>Analisa penampang Plan: analisa penampang sampelan 26/09/2017 Sta:10</p>
0

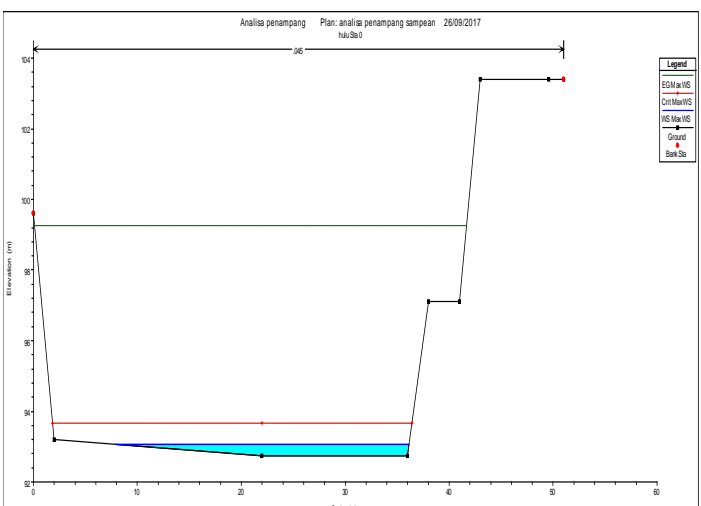
<p>Analisa penampang Plan: analisa penampang sampelan 26/09/2017 htu:Sta:0</p>

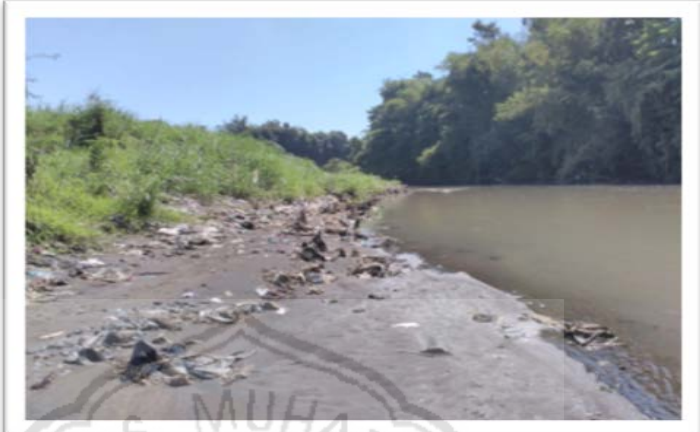
NO RIVER STA	<i>KONDISI PENAMPANG SUNGAI DI LAPANGAN</i>
80

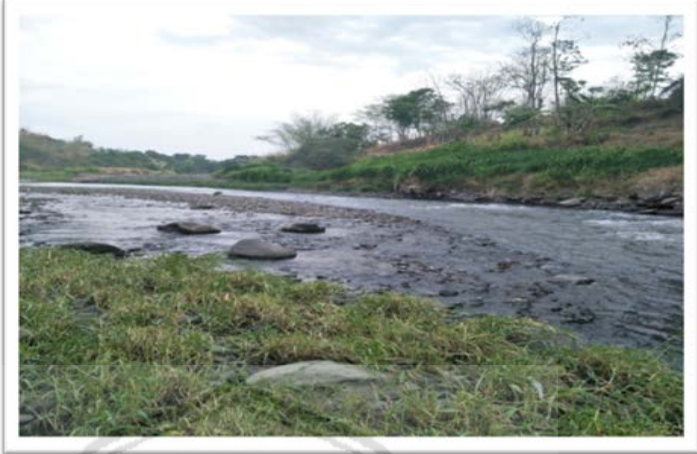
NO RIVER STA	<i>KONDISI PENAMPANG SUNGAI DI LAPANGAN</i>
50

A photograph showing a wide river channel with several large, smooth, grey rocks protruding from the water. The banks are covered in green grass and some trees are visible in the background under a cloudy sky.
40

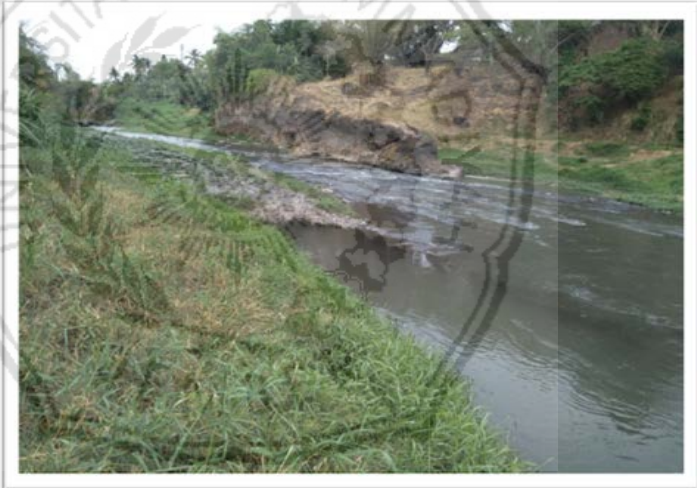
A photograph of a river with a steep, eroded bank on the right side. The water is dark and reflects the surrounding greenery. The foreground shows dense green grass and some trees. A large, faint watermark of a university seal is overlaid on the image.
